SHOCK AND VIBRATION TESTING OF LCD MONITORS

ATS JOB # D132779

HOPE INDUSTRIAL SYSTEMS, INC.
1325 NORTHMEADOW PARKWAY, SUITE 100
ROSWELL, GA 30076

MATERIALS TEST REPORT

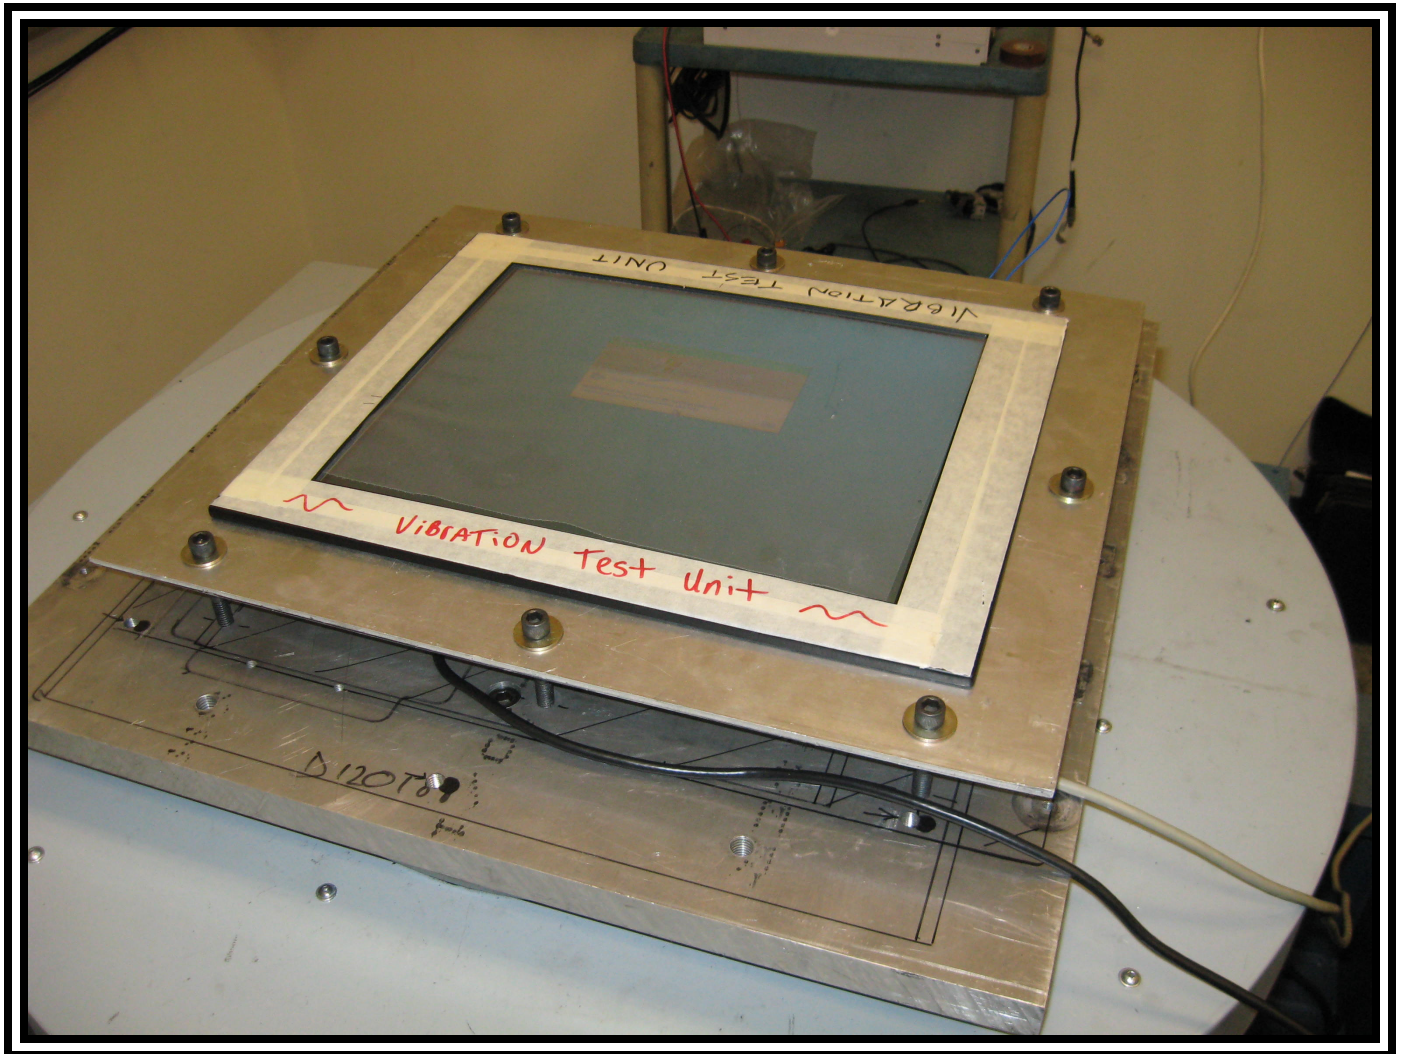
Figure 1: View of the test setup for Test 6 (mechanical shock) and Test 11 (sinusoidal vibration)
Vertical Axis

Test 6: Mechanical Shock (operating)
Figures 1 and 2 show the setup used for this test.
A video signal was applied to the monitors during the exposure.
A total of 200 shocks per axis were applied. Each shock had an amplitude of 15g, a duration of 6ms and a ½-sine time waveform. Figures 5 and 6 show representative shocks for this test (positive and negative direction).

The setup was identical to the setup used for Test 6 (mechanical shock).

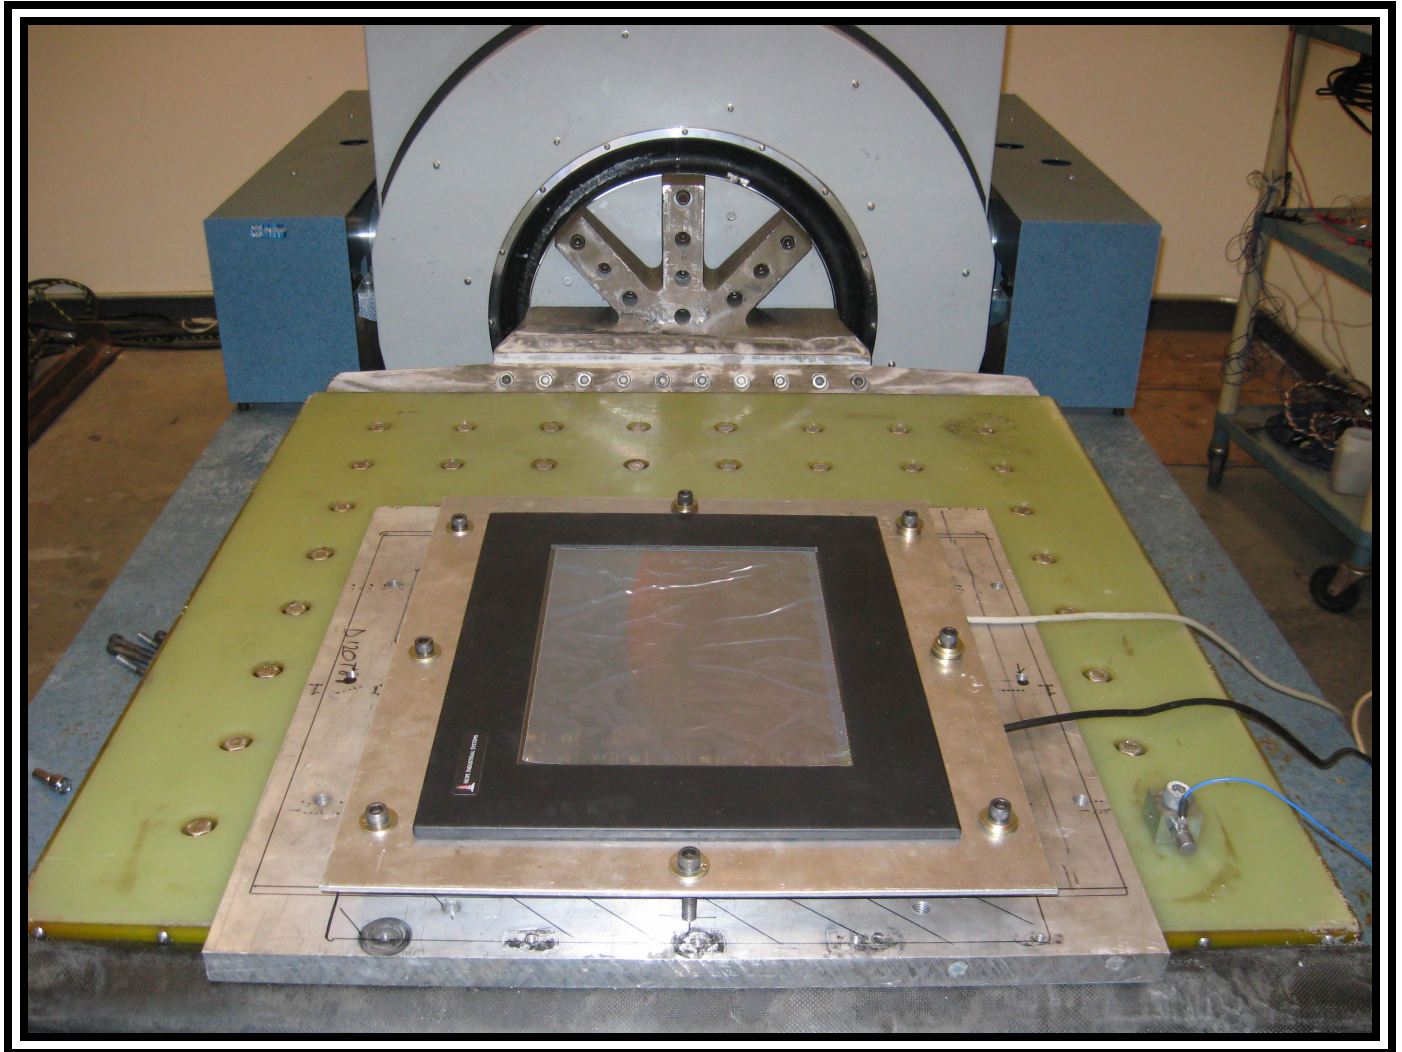
Figure 2: View of the test setup for Test 6 (mechanical shock) and Test 11 (sinusoidal vibration)
Horizontal Axes

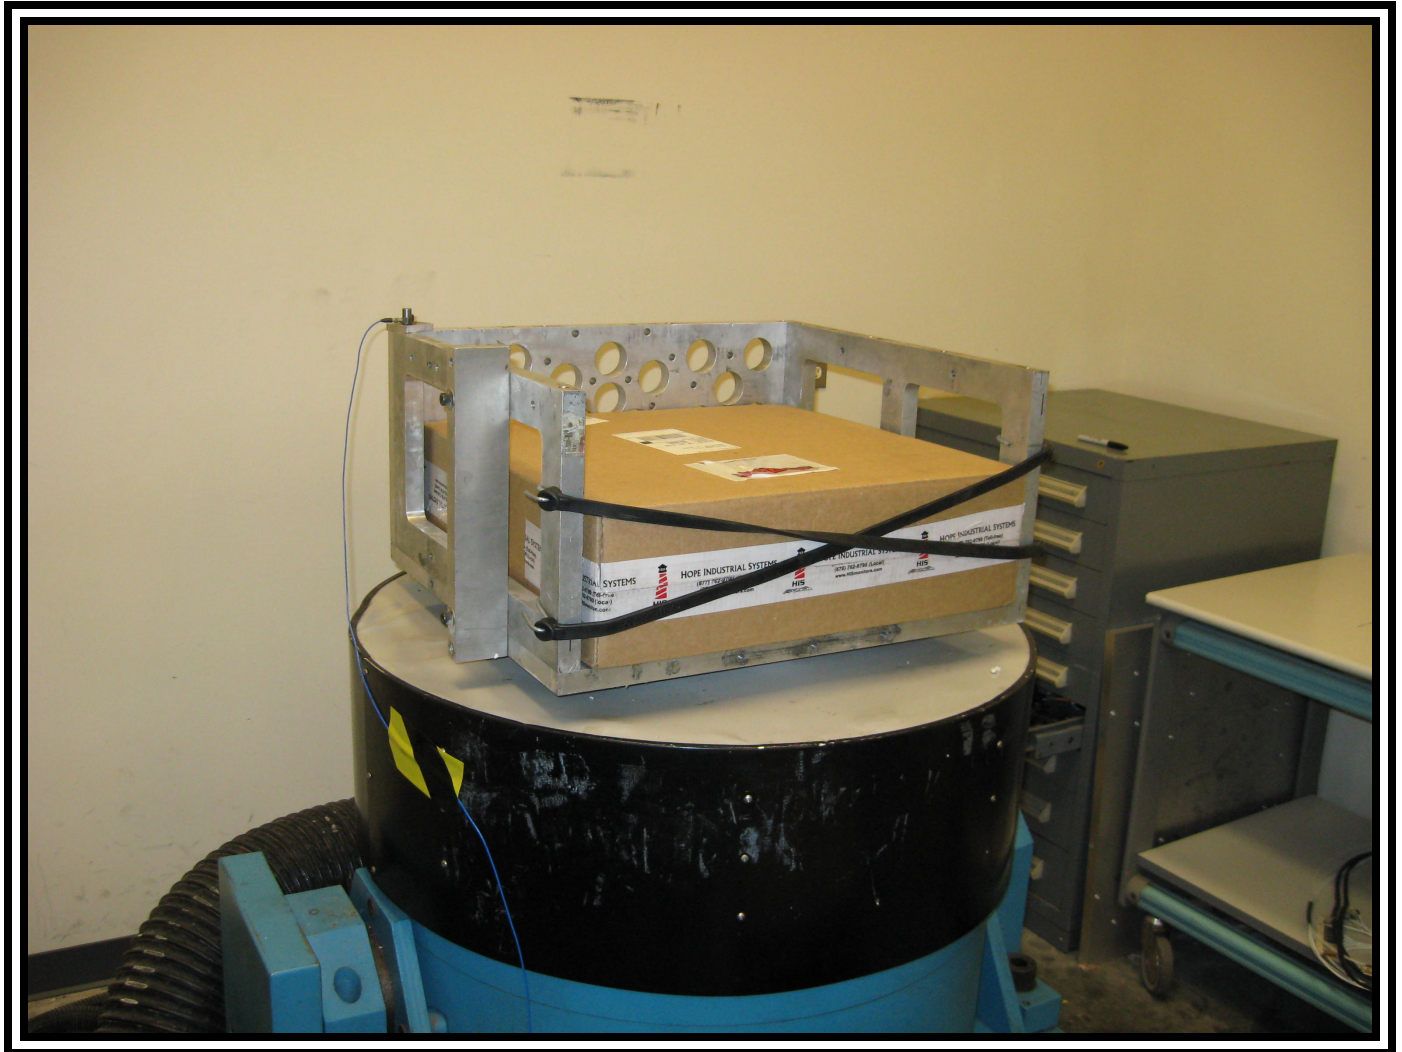
Figure 3: View of the test setup for Test 10 (random vibration)
Vertical Axis

Test 10: Random vibration (non-operating)
The displays were tested in a packaged configuration.
The packages were placed into a fixture to simulate a shipping environment (see Figures 3 and 4).
A random vibration was applied for a duration of 30 minutes per axis over three mutually perpendicular axes. Figure 7 shows the random vibration profile used (PSD vs. frequency).

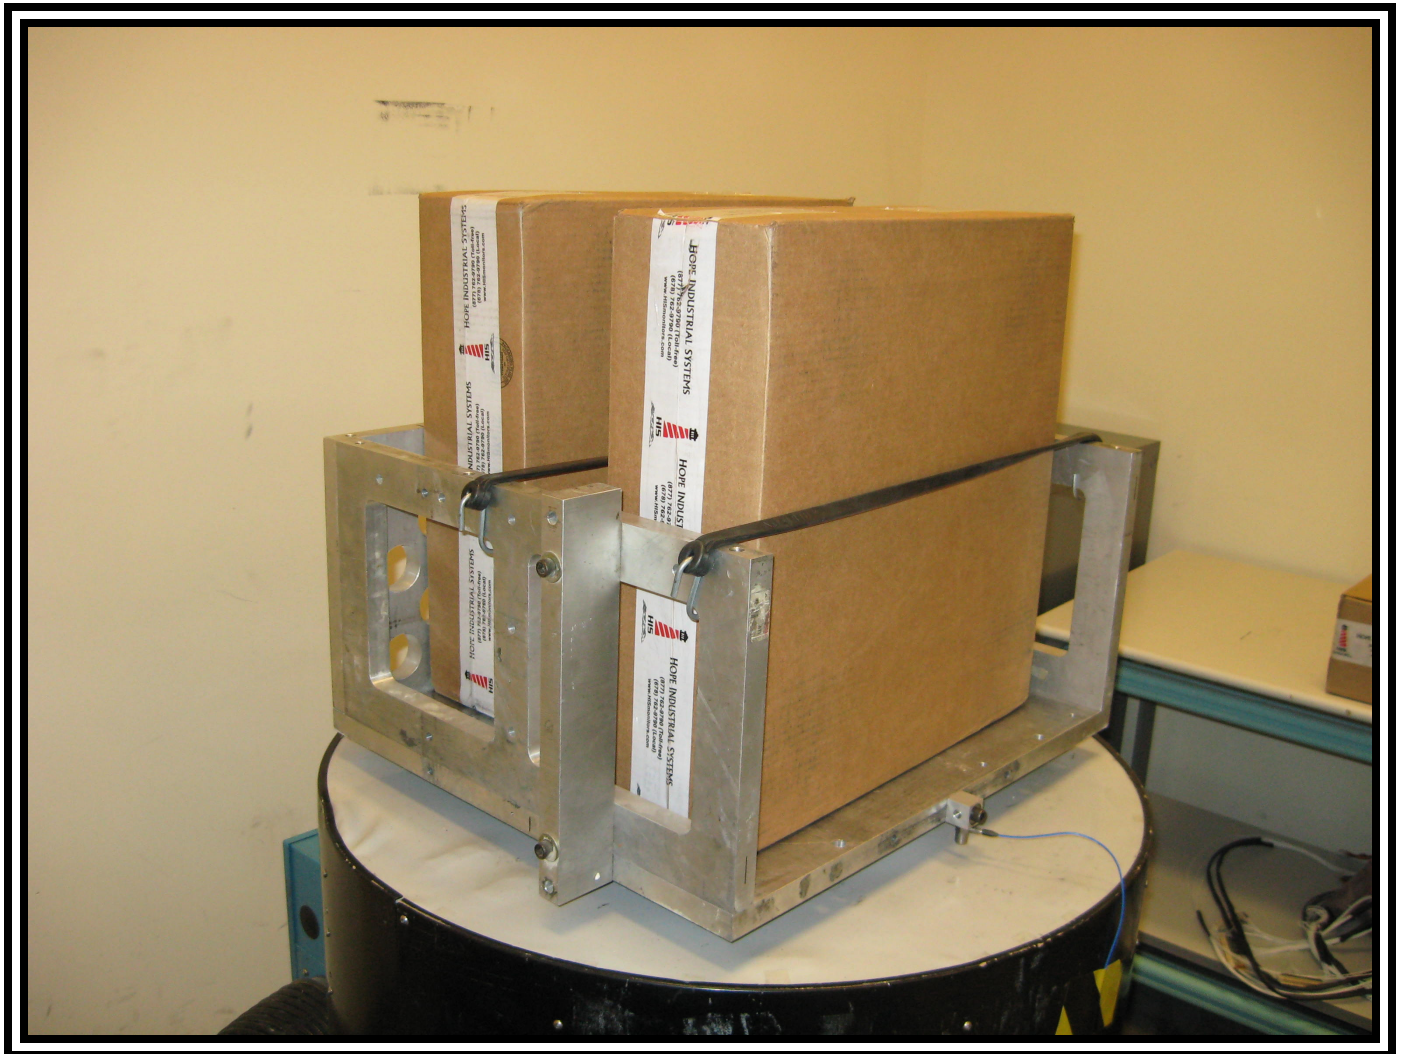
Figure 4: View of the test setup for Test 10 (random vibration)
Horizontal Axes

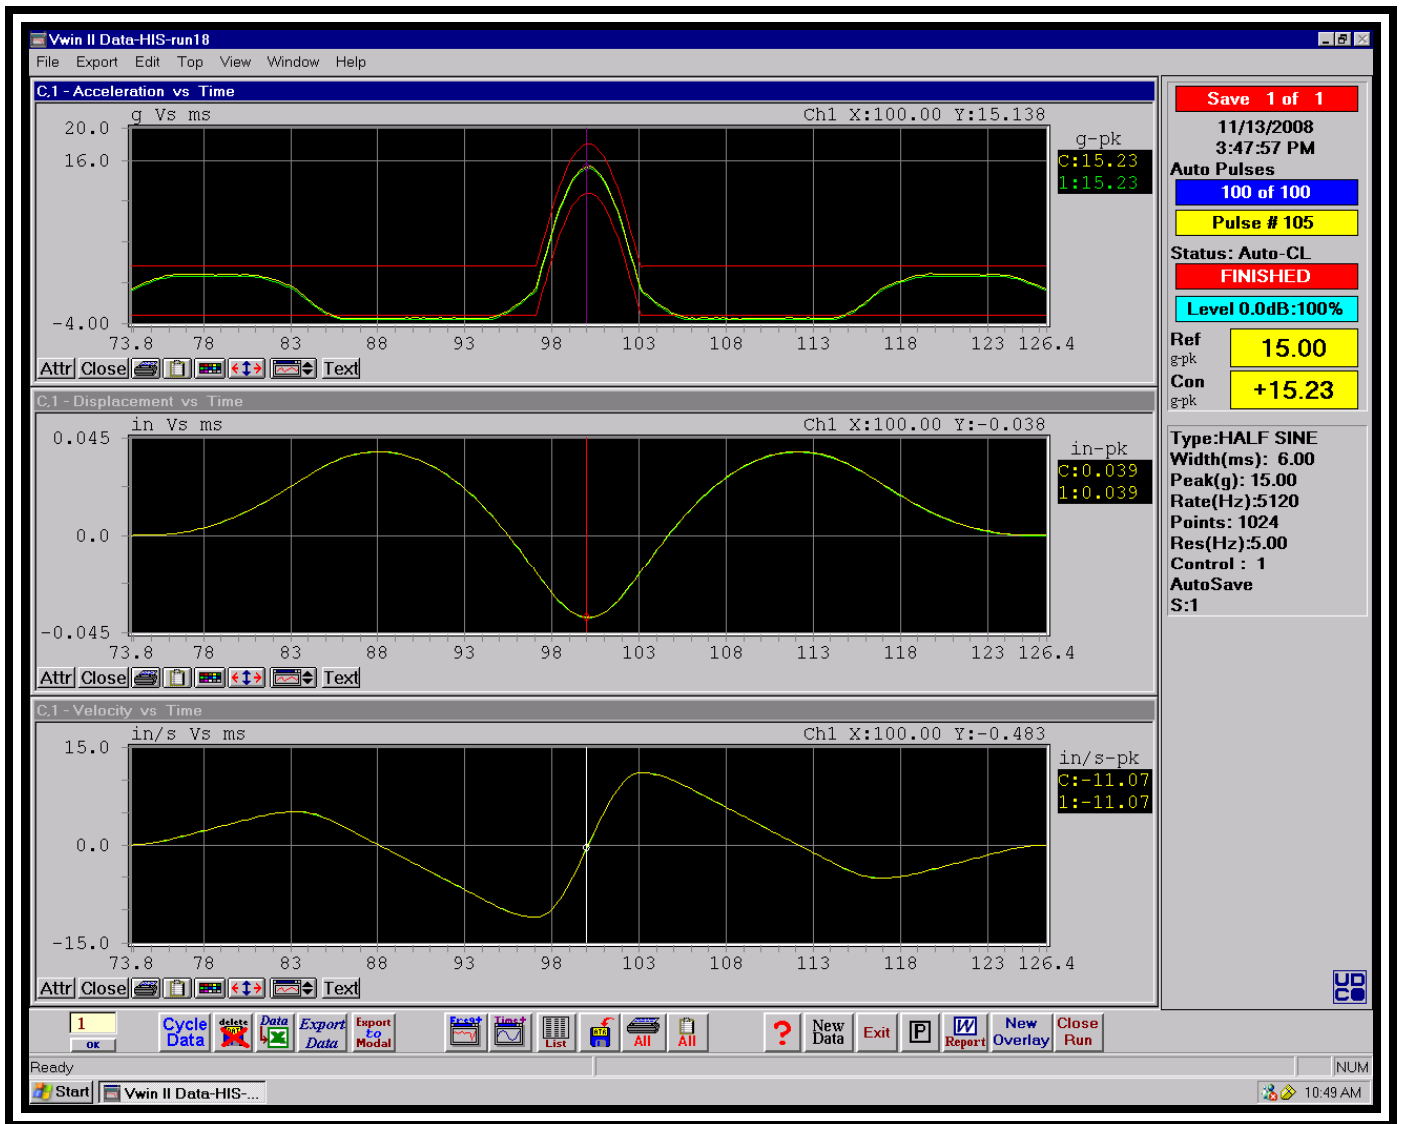
Figure 5: Time history of a representative shock pulse (15g, 6ms, ½-sine) Positive Direction

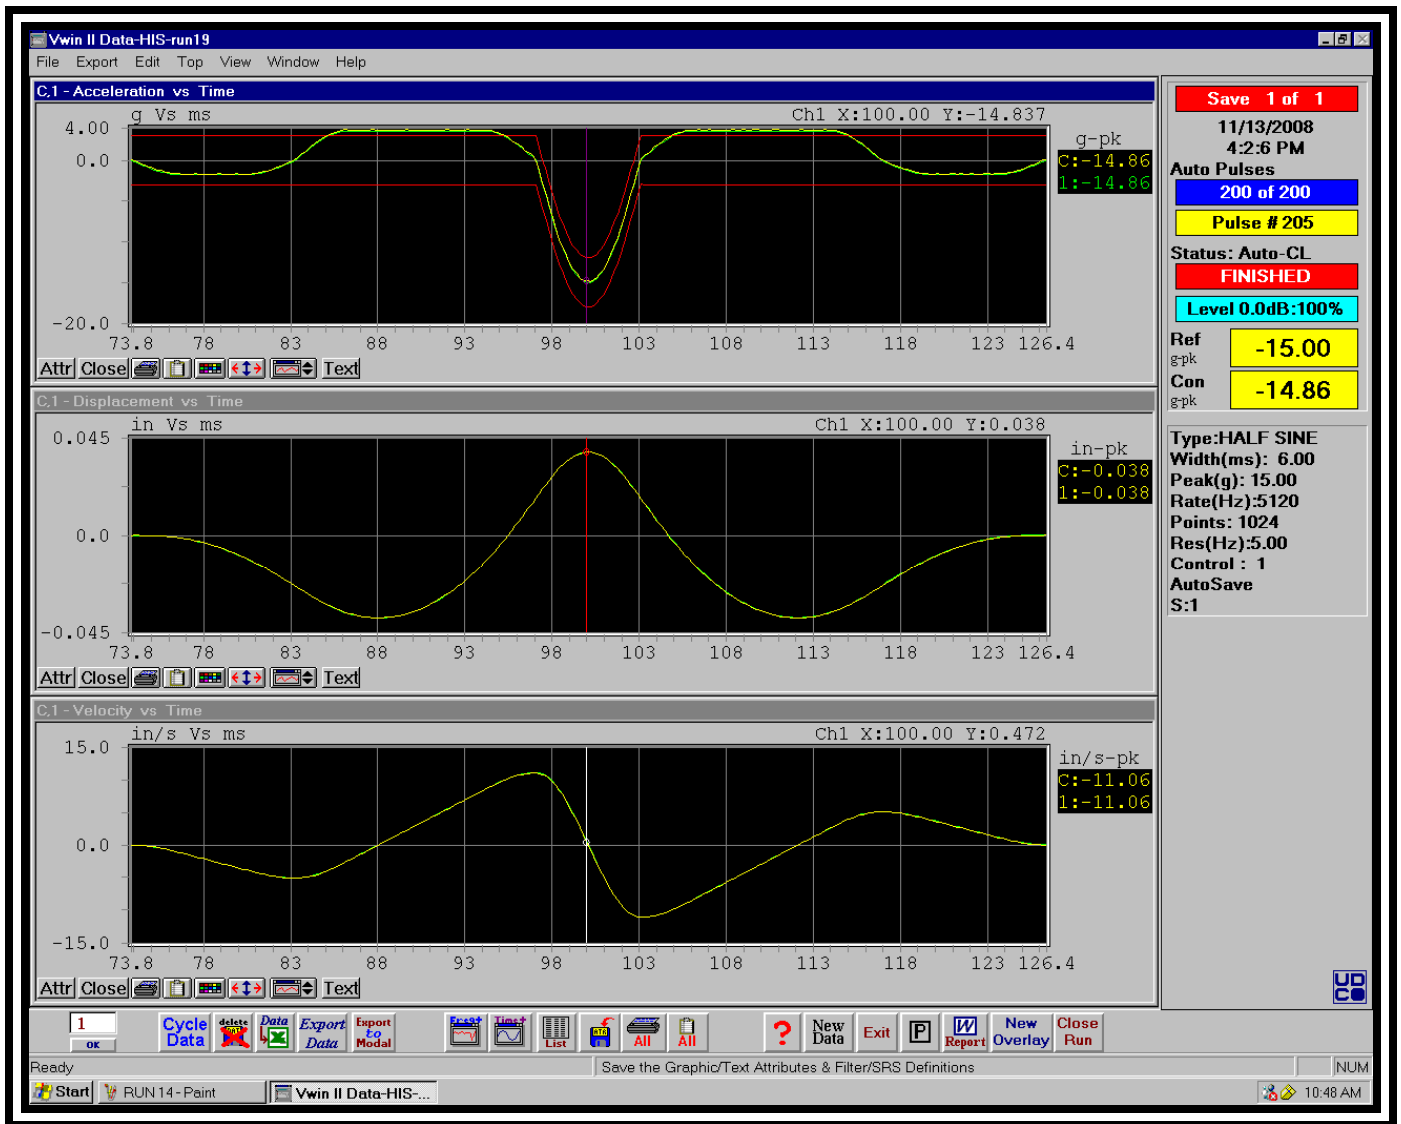
Figure 6: Time history of a representative shock pulse (15g, 6ms, ½-sine) Negative Direction

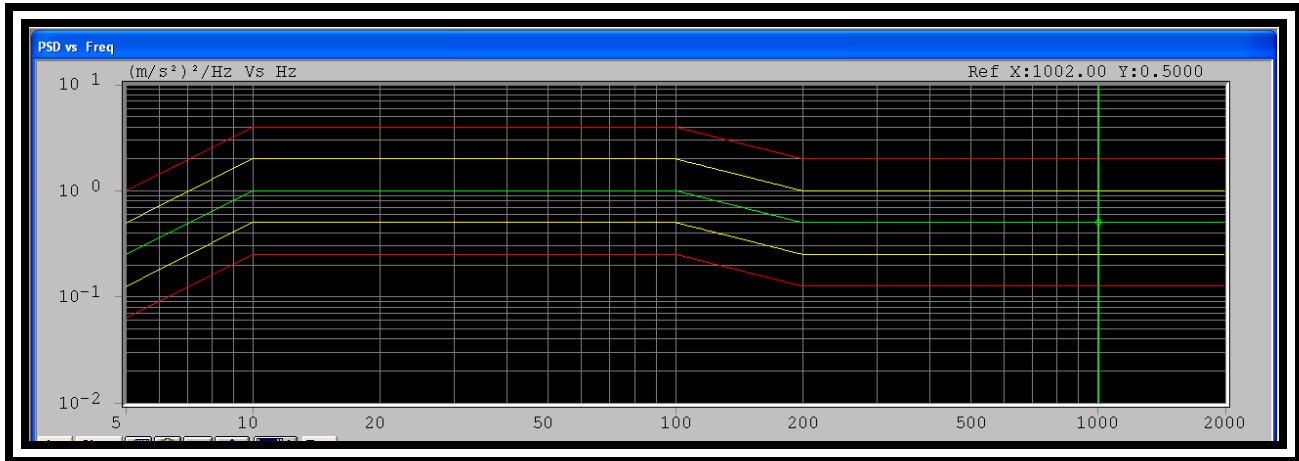
Figure 7: Random vibration profile used for Test 10
