SHOCK AND VIBRATION TESTING OF LCD MONITORS

ATS JOB # D145738

HOPE INDUSTRIAL SYSTEMS, INC.
1325 NORTHMEADOW PARKWAY, SUITE 100
ROSWELL, GA 30076

MATERIALS TEST REPORT

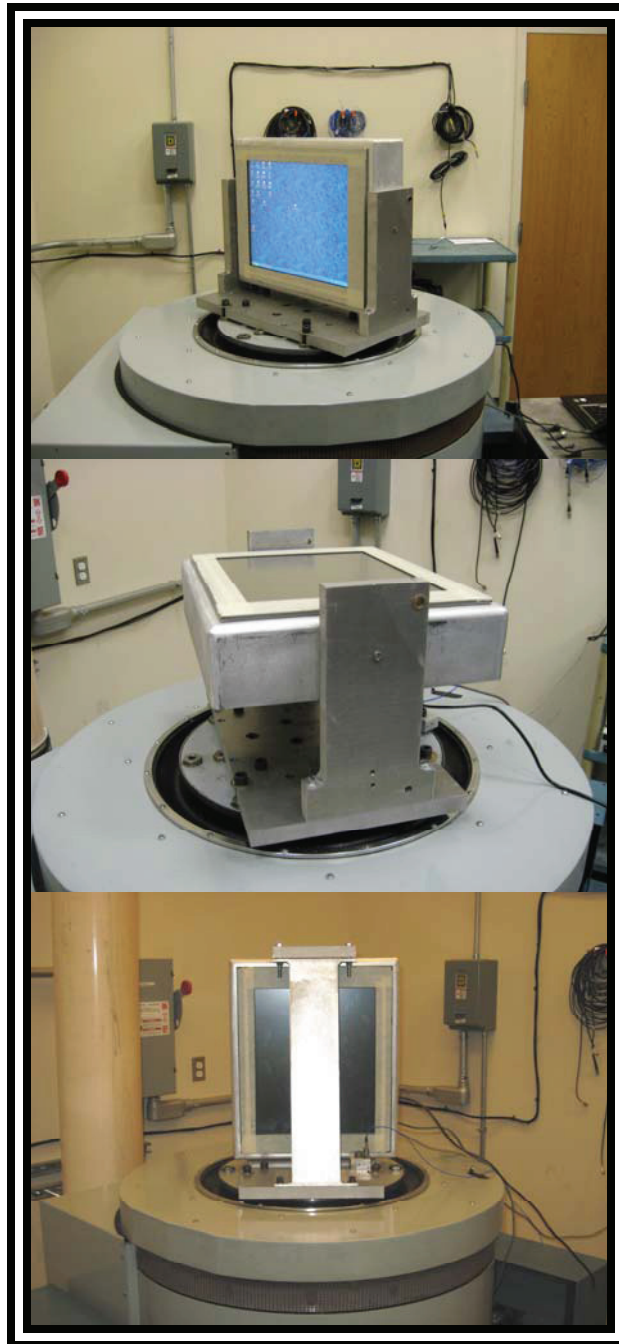
Figure 1: View of the test setup for Test 6 (Shocks) and Test 11 (Sinusoidal Vibration)

Figure 1 shows the setup used for this test.

A video signal was applied to the monitors during the exposure.

The setup was identical to the setup used for Test 6 (mechanical shock).

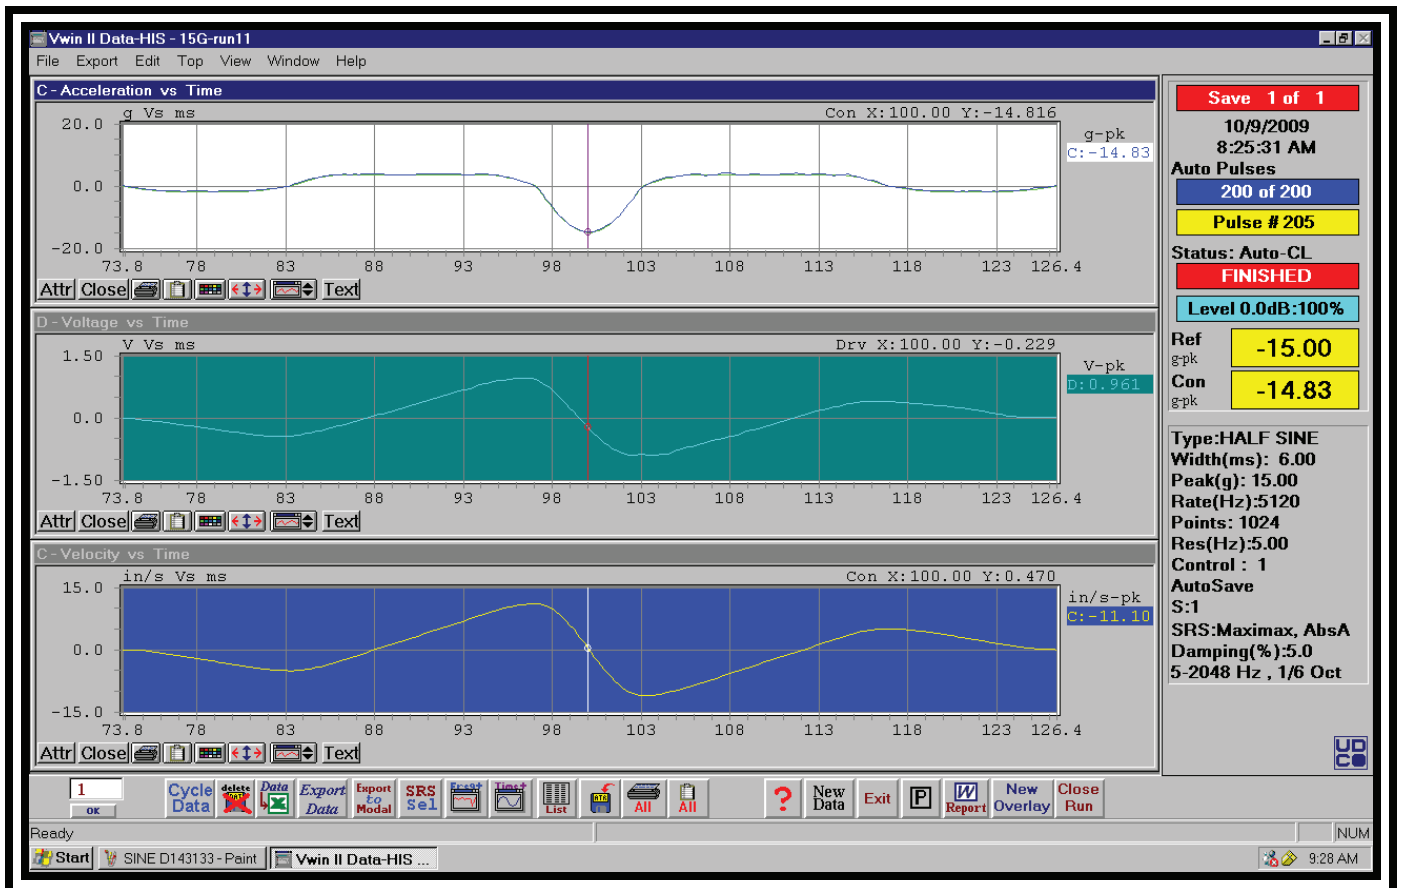
Figure 2: Time history of a representative shock pulse (15G, 6ms, 1/2-sine)

100 shocks per axis per direction were applied. Each shock had an amplitude of 15G, a pulse duration of 6ms and ½-sine time waveform. Figure 2 shows representative shocks for this test.

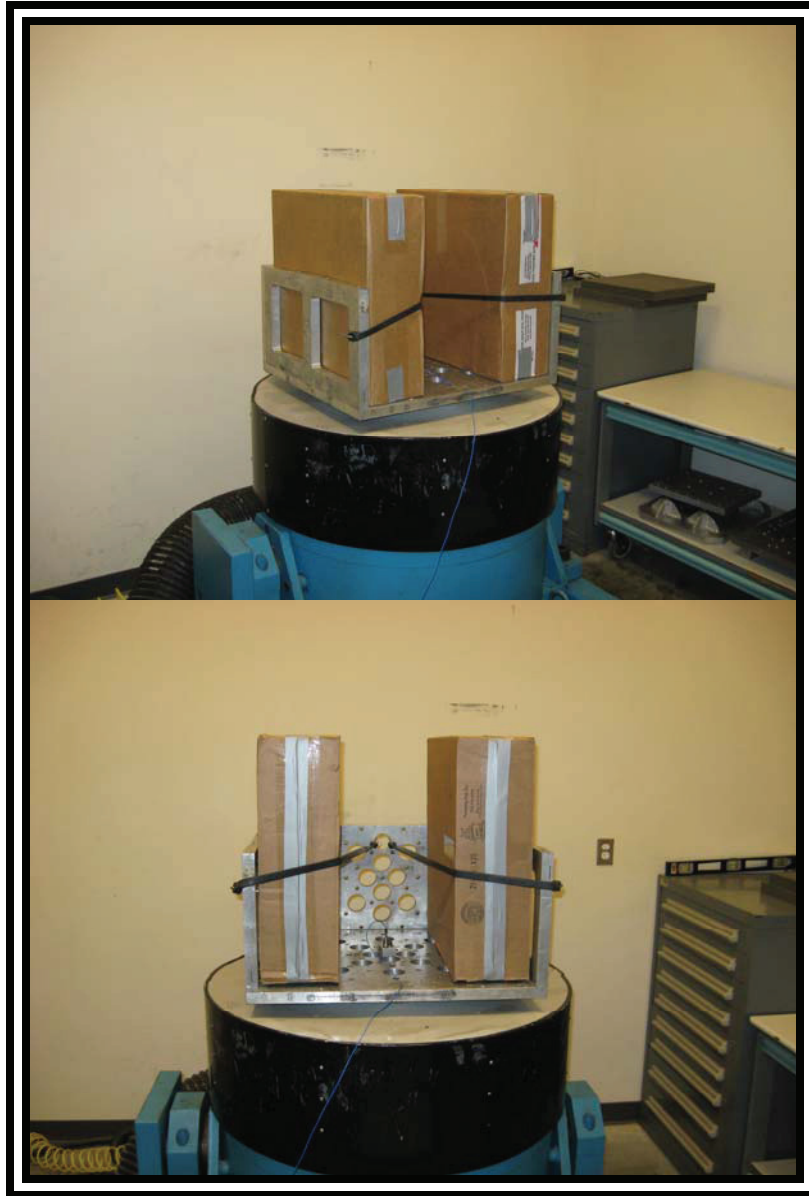
Figure 3: View of the test setup for Test 10 (random vibration)

The displays were tested in a packaged configuration.

The packages were placed into a fixture to simulate a shipping environment (see Figure 3).

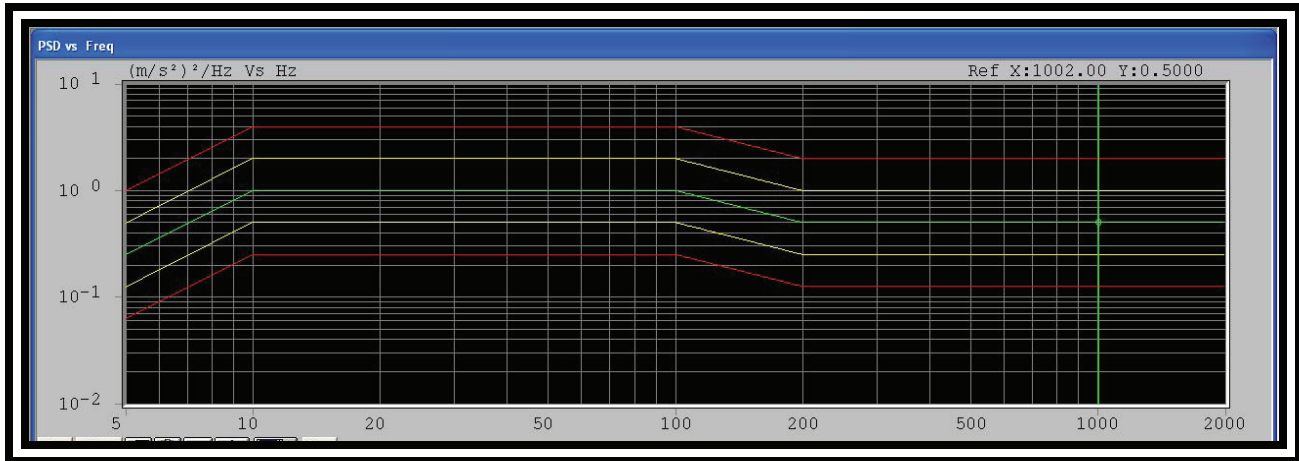
Figure 4: Random vibration profile used for Test 10

A random vibration was applied for a duration of 30 minutes per axis over three mutually perpendicular axes.

Figure 4 shows the random vibration profile used (PSD vs. frequency).

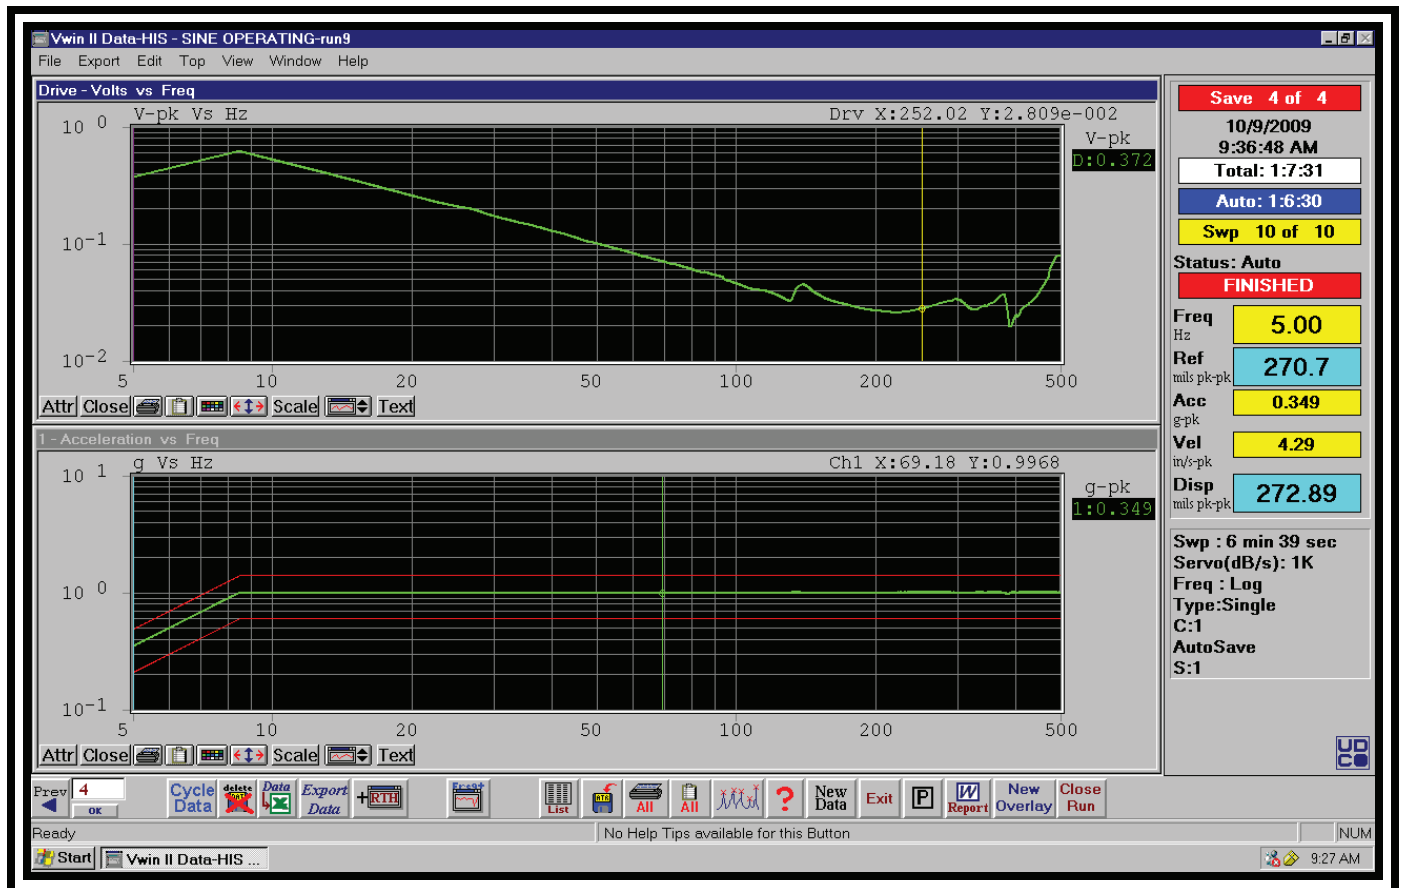
Figure 5: Sinusoidal sweep profile used for Test 11

A sinusoidal sweep (shown in Figure 5) was applied to the displays along three mutually perpendicular axes.

A total of 10 sweeps per axis was performed.
