# SHOCK AND VIBRATION TESTING OF LCD MONITORS

ATS JOB # D157097 – Rev1

## MATERIALS TEST REPORT

Shock and Vibration testing of LCD monitors

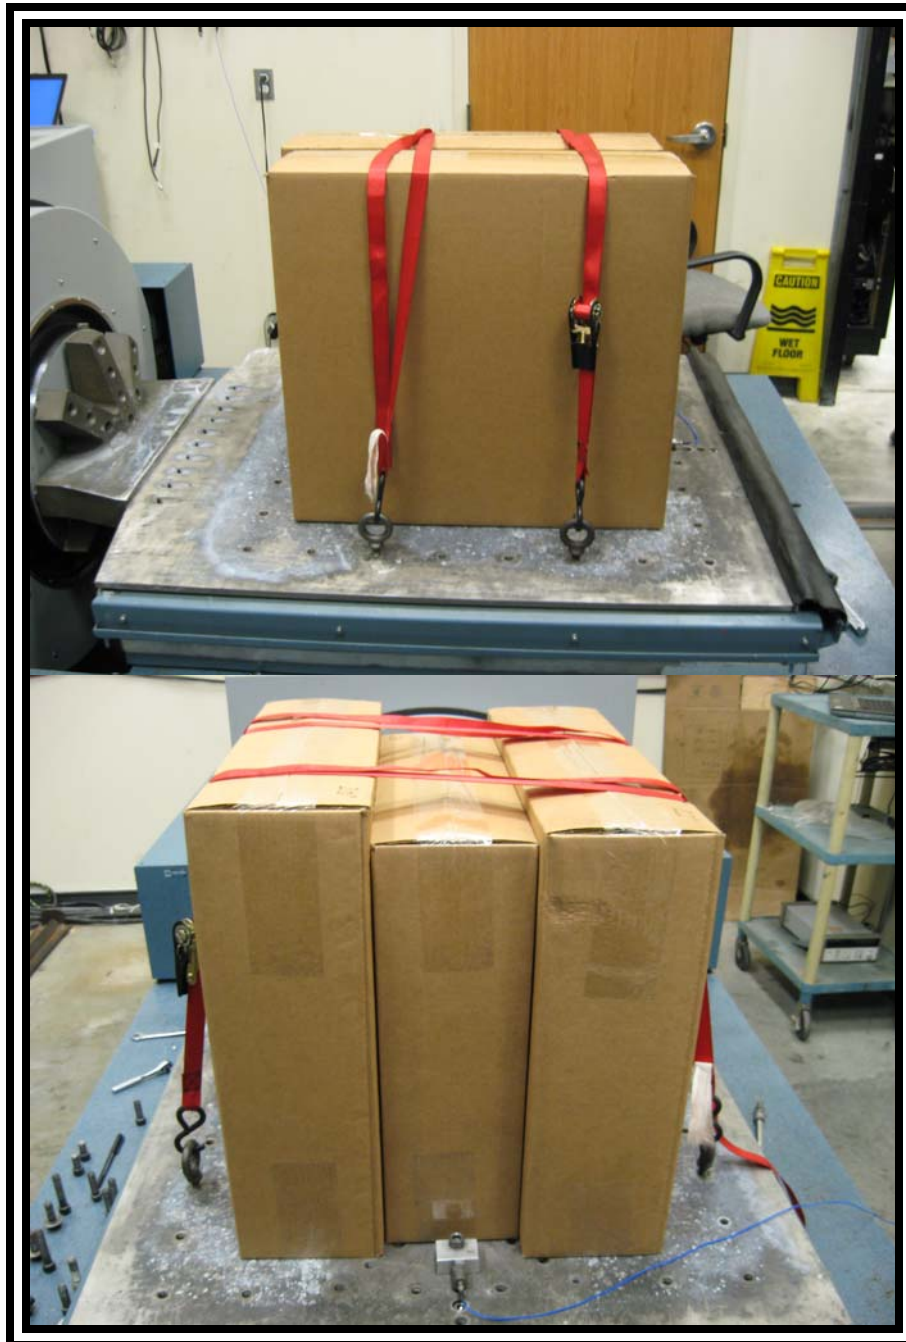
**Figure 4:** View of the test setup for Test 10 (random vibration)

The packages were placed into a fixture to simulate a shipping environment (see Figure 4).
